Manhole Inspection Summary

Manhole # **S43GG_042MH**

Insp Date: **10/22/07 2:44 PM**

Location Address: **ELLSWORTH**

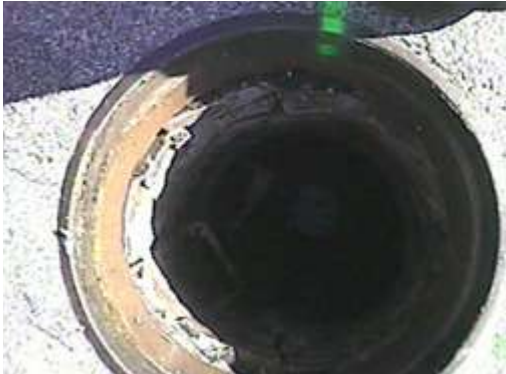
Defect 2

Offset: **3** (in.)

FRAME OFFSET

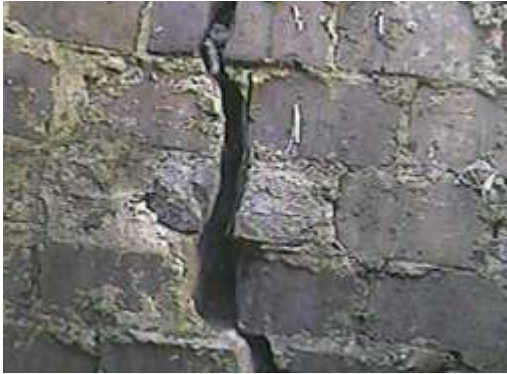
Defect 1

Condition: ☐ Sound ☒ **Cracked** ☐ Root Intrusion ☐ Loose Brick ☐ Deteriorated

CRACKED CORBEL #1

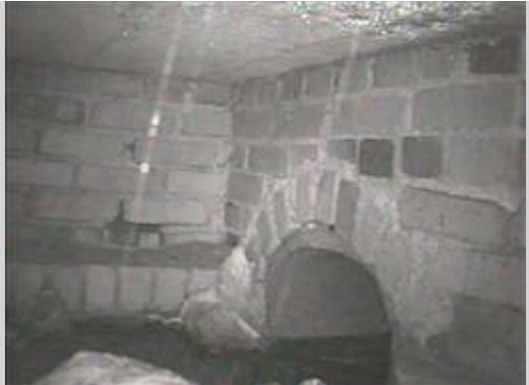
12 O'Clock Outflow

18 in. Circular Gravity Sewer
Pipe Out @ 12 O'Clock

Pipe Height: (in.) Direct
Pipe Material: **Clay** ☐ Pipe Lined
Invert Depth: **9.14** (ft.) Flow Characteristics: **Slow**
Deposits: ☐ None ☐ Mud ☐ Sludge ☒ **Debris** ☐ Grease
Silt Depth: **7** (in.) Deposits Extent: **Heavy**
Infiltration: **None** Pipe Seal Cond: **Sound**

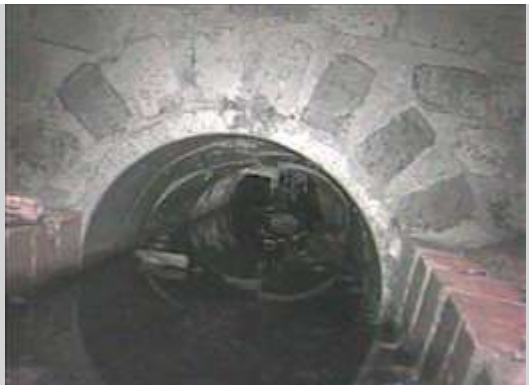
3 O'Clock Inflow

18 in. Circular Gravity Sewer
Pipe In @ 3 O'Clock

Pipe Height: **6** (in.) Direct
Pipe Material: **Clay** ☐ Pipe Lined
Invert Depth: **9.15** (ft.) Flow Characteristics: **Slow**
Deposits: ☐ None ☐ Mud ☐ Sludge ☒ **Debris** ☐ Grease
Silt Depth: **7** (in.) Deposits Extent: **Heavy**
Infiltration: **None** Pipe Seal Cond: **Sound**

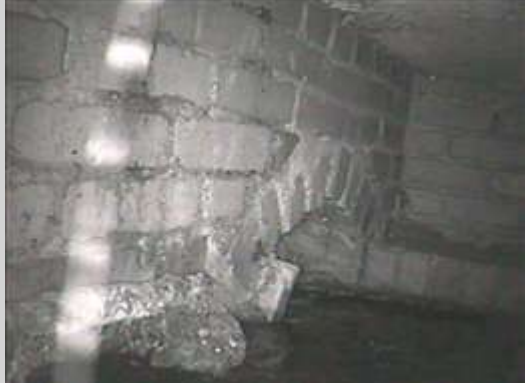
6 O'Clock Inflow

18 in. Circular Gravity Sewer
Pipe In @ 6 O'Clock

Deposits: ☐ None ☐ Mud ☐ Sludge ☒ **Debris** ☐ Grease

Silt Depth: **7** (in.) Deposits Extent: **Heavy**
